(10) International Publication Number
WO 01/42802 A1

(54) Title: METHOD FOR DIAGNOSING DEGRADATION IN AIRCRAFT WIRING

METHOD FOR DIAGNOSING DEGRADATION IN AIRCRAFT WIRING

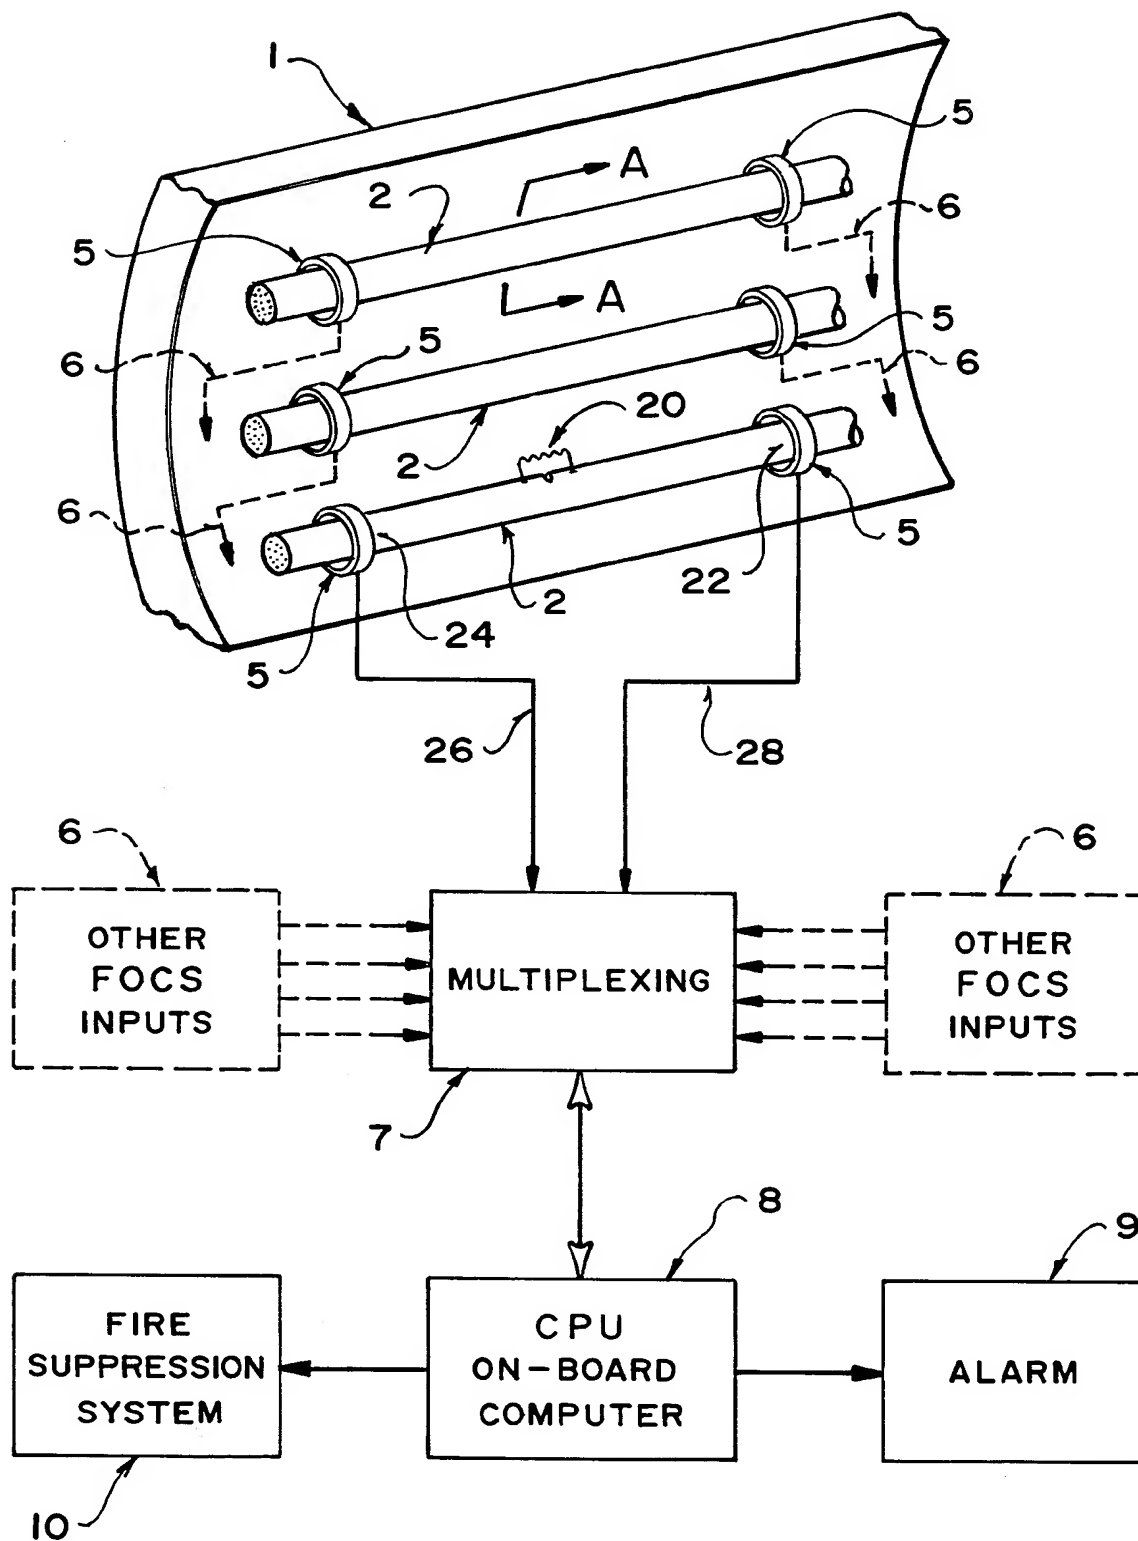
FIG. 1

- 5 Fig. 1 is a schematic illustration and block diagram of an aircraft wiring system with the proposed diagnostic; and
 Fig. 2 is a cross-section taken along lines A-A of Figure 1 of a typical wiring cable used in an aircraft.

- With reference to Figures 1 and 2, a standard aircraft wiring cable (not to scale), designated as 2, carries an electrical current, typically from a few milliamperes to 10's of amperes at 400 Hz. The cable consists of solid or
15 stranded conductors of copper or aluminum, insulated with PTFE or Polyimide and twisted in pairs 3 and bundled into a large cable with an overall jacket 4. Power conductors are typically single core, whereas the control cables are twisted pairs. Some of these cables also carry direct current, although most carry the 400 Hz ac current generated by the airplane's generator. These cable
20 bundles are mounted on the aircraft fuselage 1 or in cable trays and electronics bays inside the aircraft.

- Extremely accurate optical current sensors 5, which may be fibre, slab or crystal are now available to measure the flow of current in the aircraft
25 wiring. Such sensors have a resolution of 5×10^{-6} amperes and a bandwidth of dc to 50 kHz. Optical sensors of this general type are typically manufactured by Sumitomo in Japan and others. A suitable optical current sensor is wrapped around or clipped over the cables 2 at two spaced locations 22, 24. The light within the fibre, slab or crystal is perturbed by the electromagnetic field
30 produced by the current in the conductor and the sensor can be calibrated to measure the current in the conductor with sufficient accuracy and linearity. The output from each optical sensor is communicated to the central processing unit or CPU 8 via conductors 26, 28 and a multiplexer 7 that allows

simultaneous processing of multiple signals 6 from multiple fibre optic current sensors. The CPU 8 calculates the difference between the cable conductor current flows at 22 and 24 at different frequencies, within a bandwidth excluding 400 Hz. To reduce the effects of background noise, time averaging
5 of the data may be carried out over an extended period. Since sparking or an arc discharge 20 generates a high frequency component in the range of 10 kHz to 50 kHz, readings are taken at frequencies in the 10 kHz to 50 kHz range. The differential is then processed by the CPU 8 at those frequencies, the data is analyzed by the CPU and the presence and location of a potential cable wiring
10 fault may be indicated based on that analysis. The CPU will generate an alarm 9 and depending upon the received signal level from the sensor will initiate a sectionalized fire suppression system 10.

The location of the cable wiring fault or sparking may be calculated by
15 the CPU 8 using a technique called time domain reflectometry or TDR. This method is disclosed in the following publication: Matthew S. Mashikian, "Partial Discharge Location as a Diagnostic Tool for Power Tools" 1999 *IEEE/PES Transmission and Distribution Conference*, New Orleans La., April 11-16, 1999, Panel on Diagnostic Measurement Techniques for Power Cables.
20 See in particular Figure 3.
